Composite Solution Permanently Reinforces Seam Weld Anomaly on 16" Ethylene Line

Louisiana

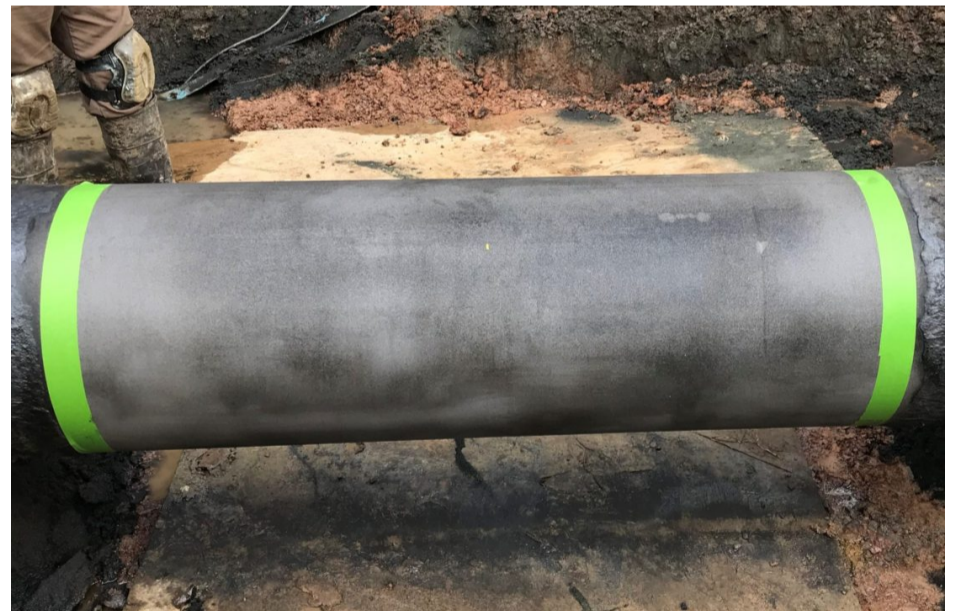
Technicians grit blasted the damaged area of the pipe and wiped it with acetone to prepare the surface for composite installation.

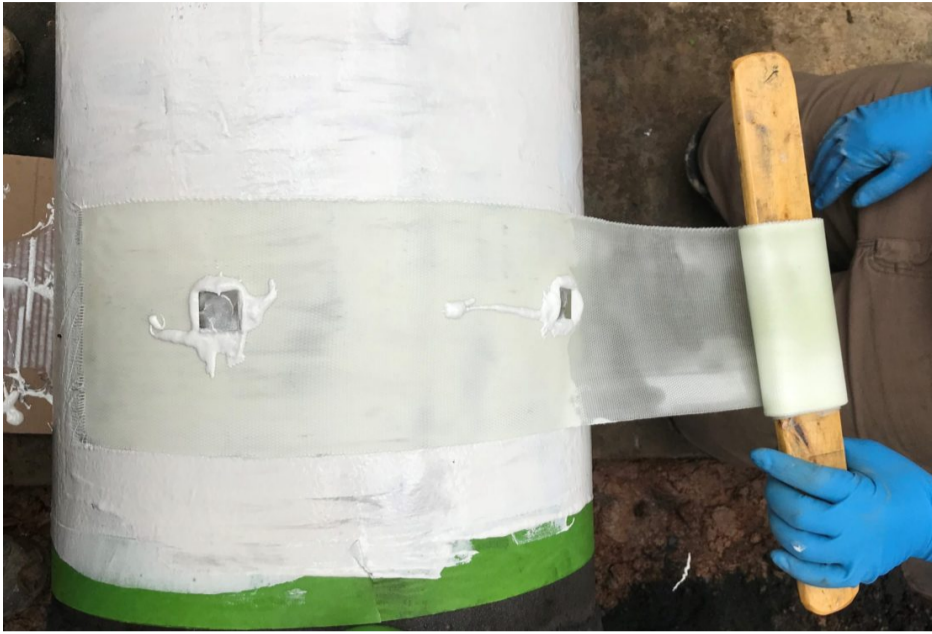
With the filler material and epoxy coating applied, technicians install a fiberglass isolation layer with magnetic markers that can be detected using an intelligent pig for inline inspection.

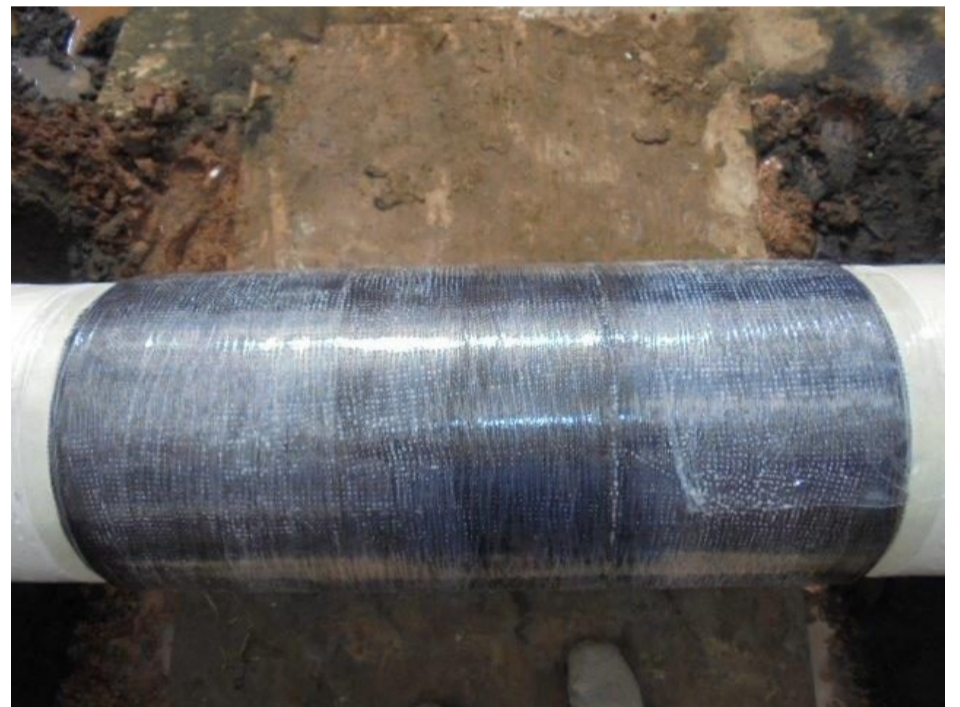
A 3-ft (1-m) section of damaged pipeline was covered with 24 layers of composite solution and overwrapped with compression film, which was perforated to allow the composite underneath to completely cure.

The next step was to cover the entire 3-ft (1-m) long area with 24 layers of 12-inch (304.8-mm) wide Atlas composite wrap, layer over layer, to provide reinforcement along the damaged weld. Once the team had securely placed all the layers of the composite, they covered the repair area with compression film, perforated it, and allowed the composite to cure.
