# Composite Solution Reinforces LF-ERW Seam Anomaly on Ethylene Line

Louisiana

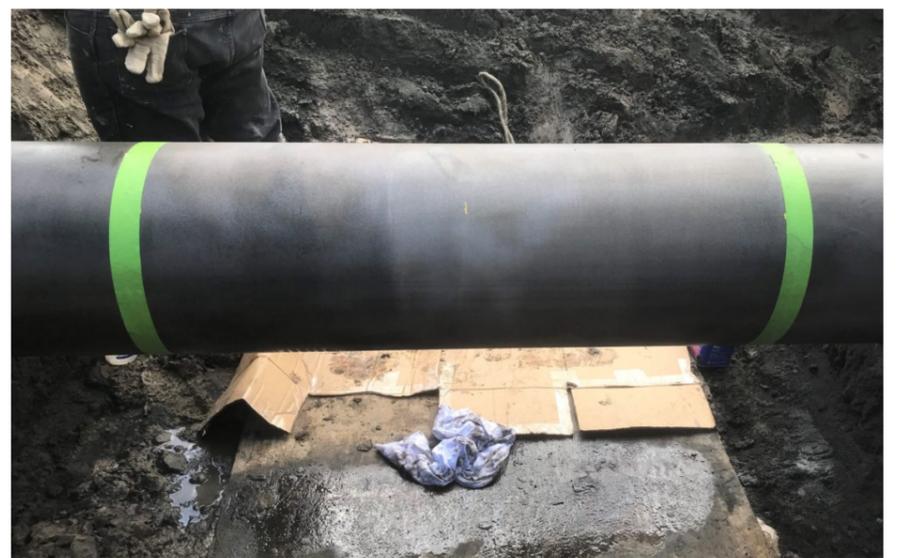
*Technicians prepared the pipe surface to a near-white profile and wiped it with acetone in preparation for the composite installation.*

Two CSNRI supervisors and a team of installers from a local contractor mobilized to the site to carry out this seam weld repair. The first step was to prepare the pipe for the composite repair. Technicians removed the pipe coating and used a bristle blaster to achieve a surface profile equivalent to SA2.5. Next, they wiped the prepared pipe with acetone and applied special filler material to tented/voided areas. With the filler material in place, the team covered the repair area with a two-part epoxy primer and placed a fiberglass isolation layer with magnetic markers over the pipe so the repair area can be detected by an intelligent pig during inline inspections later on when the line is reburied.

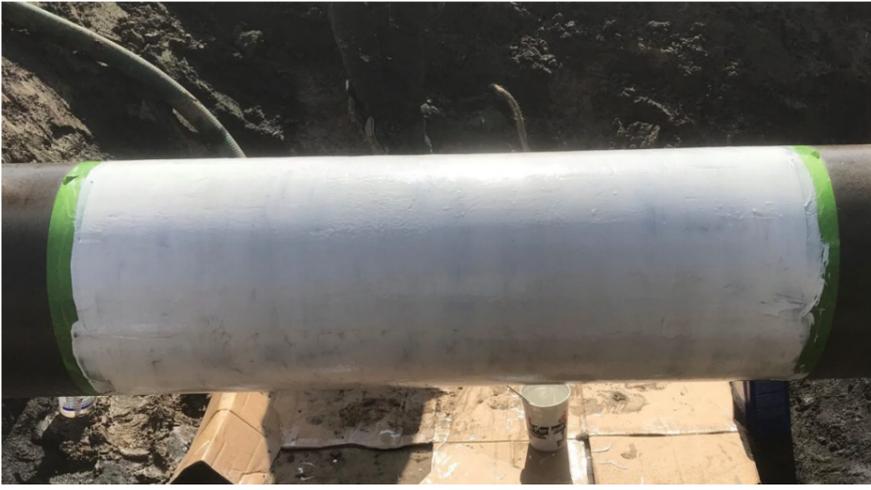
*Installers applied a special two-part epoxy coating to the repair zone.*

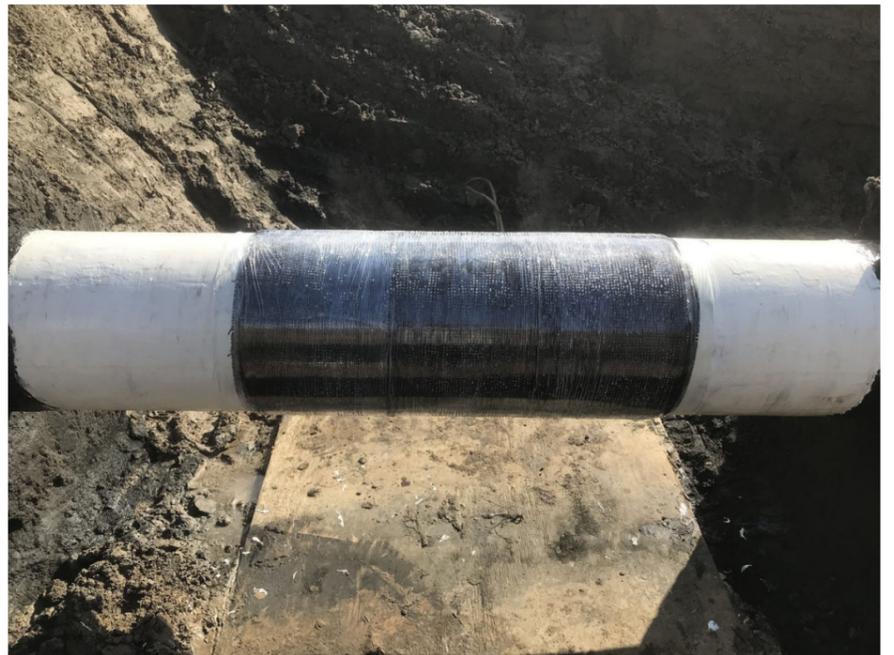
*The team installed 24 layers of composite cloth over a 3-ft (1-m) section of pipeline, then covered the repair area with constrictor wrap and perforated it to allow the composite to cure.*

The next step was to cover the entire 3-ft (1-m) long area with 24 layers of 12-inch (304.8-mm) wide Atlas composite wrap, layer over layer, to provide reinforcement along the LF-ERW seam weld anomaly. Once the team had securely placed all the layers of the composite, they covered the repair area with compression film, perforated it, and allowed the composite to cure.

When the cure was complete, the compression film was removed, and the line was fit for continued safe service. The repair area was later covered with a topcoat selected by the owner.
